PERFORMANCE OF DAMAGE-PROTECTED BEAM-COLUMN JOINTS SUBJECTED TO BI-DIRECTIONAL LATERAL LOADING

SUMMARY

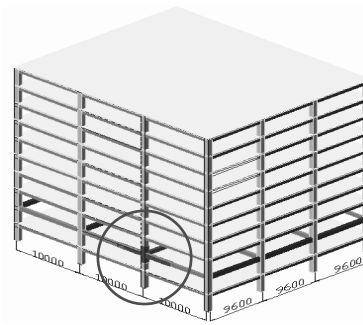
As shown in Figure 1, the prototype is a ten-storey reinforced concrete frame building with three 10m bays in each direction. This generic structure, commonly known as the “red book” building [15], was designed according to the New Zealand concrete standard [7] for intermediate soil in Christchurch, New Zealand. Keeping all other variables constant, the same structure was designed and detailed according to damage avoidance principles, thereby resulting in precast beams and columns being connected via a post-tensioning system with other devices to provide supplemental energy dissipation. The DAD building was designed with precast flooring units running in the transverse direction and seated on the transverse beams, leaving the longitudinal beams to resist predominately seismic forces.

Figure 1: The prototype structure, showing the location of the subassembly.

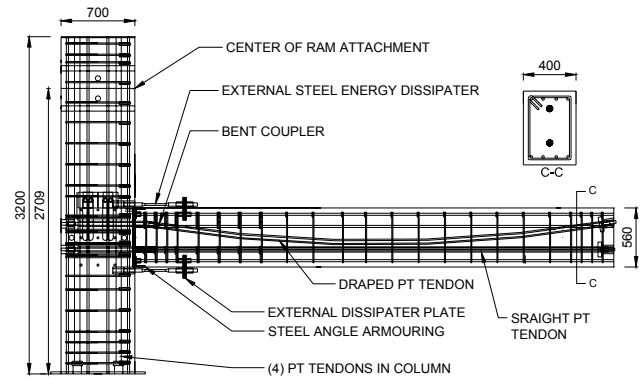
Reinforcing details of the column are given in Figure 2 and Figure 3. An axial load of 2000kN due to self weight of the above floors was simulated in the 700x700mm column by prestressed Macalloy™ 32mm diameter high strength threaded rods. Three 20mm thick mild steel plates were cast at the column faces where precast beams were joined. The minimum reinforcement ratio, $\rho_t = 0.008$ was provided using 12 HD20 threaded bars (Reidbars™). This low reinforcement ratio eased congestion in the joint region. To transfer shear forces through the joint, five double HR12 hoops spaced at 100mm centres were provided. The design compression strength of the column was taken to be $f'_c = 45\text{MPa}$. PVC ducts were placed at a 20 degree angle in each seismic beam and horizontal through the gravity beam for the post-tensioning rods.

Figure 2: Elevation of the gravity beam and column.

Reinforcing details of the seismic beams and gravity beam are given in Figure 2 and Figure 3, respectively. A cracked elastic design was used to detail longitudinal reinforcement in the precast beam segments. In this design approach, sufficient quantities of mild steel are provided to ensure that yield of longitudinal reinforcing is prevented and concrete compressive stresses are below $0.7f'_c$. This ensures precast elements remain essentially elastic even when the connection reaches over-strength. Shear design of the precast elements followed the New Zealand concrete code [7], with a total initial axial load of 400kN provided by the post-tensioning rods. Within the mid section of the beams, only minimal transverse steel was used, thus a stirrup spacing of $d/2$ was adopted. A tighter, 100mm spacing was provided at the ends. Additional stirrups near the joint were provided to provide confinement for the concrete to withstand large compressive stress expected in the end regions.

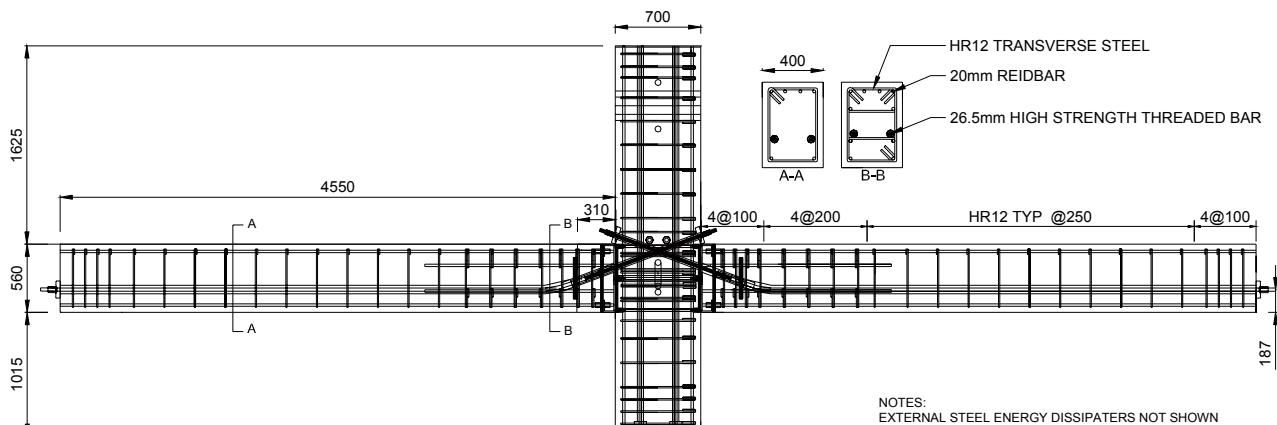
Figure 3: Elevation of the seismic beams and column.

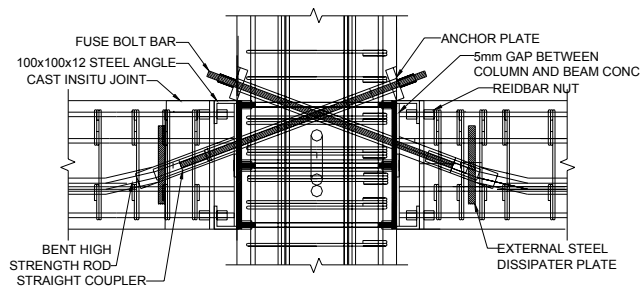
A detail of the seismic beam-column joint is given in Figure 4. The seismic beams utilized a straight coupler system where the tendons were pre-bent at the joint end to a radius of approximately 1.8m. This allowed proper alignment with the angled rod running through the column. This shorter rod, termed the 'bolt bar', was machined to 75% of its effective area to ensure any yielding in the post-tensioning system would be limited to the replaceable column bolt bar. At the beam end, a 100x100x12 inverted steel angle was used at top

Figure 4: Detail of the seismic beam-column joint.

and bottom of the joint and the face of concrete was recessed 5mm. This ensured that contact with the column was limited to the steel and allowed the angle's buried flange to mechanically develop the beam's longitudinal steel using ReidbarTM nuts.

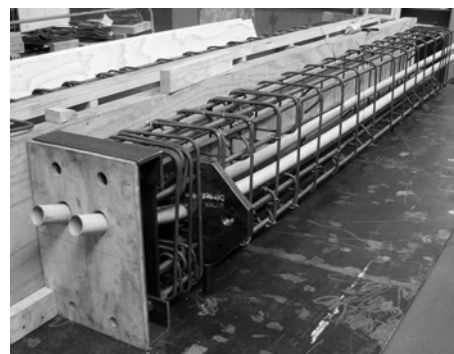
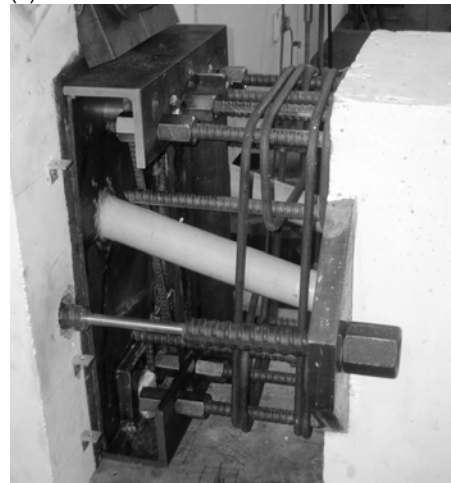
By the nature of precast concrete and rocking connections, it is critical that the face of the beam be aligned flush with the column. Therefore, offsite erection of a full length beam section may lead to on-site misalignment issues which may effect rocking behaviour. To mitigate this and allow for construction tolerances similar to current standards, a 310mm cast insitu closure pour was provided on the west seismic beam. This closure pour is implemented on-site after the armouring angles have been adjusted to ensure a flush face at both ends and the post tensioning rods are coupled together. High strength, fibre-reinforced concrete was used in the insitu end to compare its behaviour to the regular strength concrete of the east beam. The compressive strength of the high strength concrete was tested and found to be $f'_c = 70\text{MPa}$. The east beam and the remainder of the west beam concrete was found to be $f'_c = 37\text{MPa}$. A photograph of the beam prior to pouring and the cast insitu closure pour is given in Figure 5.

Figure 5: Precast concrete beams showing: (a) the beam cage; and (b) the cast insitu closure pour.

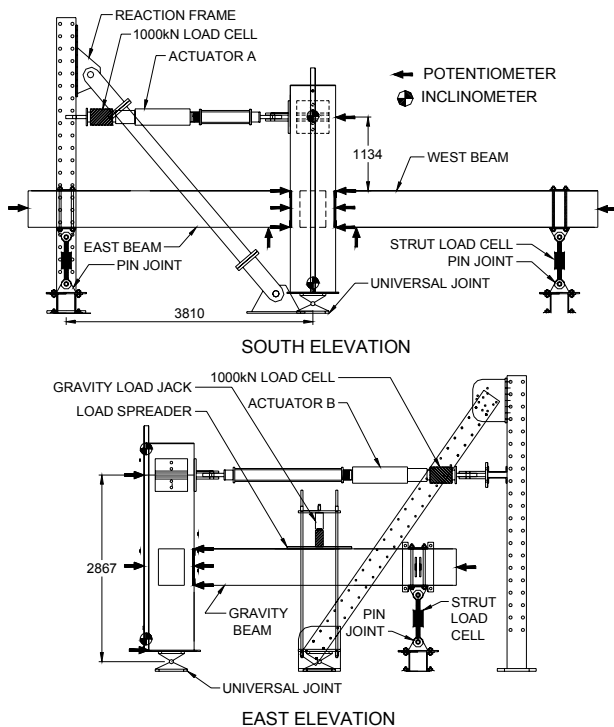
Figure 6 presents two elevations of the test setup. Loads were applied to the specimen by three hydraulic actuators. Actuators A and B were installed to the reaction frame and top of the west and south face of the column, respectively. Actuator C (shown in Figure 7) was installed in the east-west direction at the end of the gravity beam. This actuator was intended to keep the specimen movement in-plane during uni-directional testing

and provide a measure of torsion in the specimen. Actuator C's movement was synchronised to approximately one half the displacement of Actuator A. A constant 120kN load was applied at midsection of the gravity beam through a 300kN hydraulic jack, simulating the weight of the precast flooring panels. The load was spread over a 1.5m timber block and developed into the strong floor through four high strength threaded rods. Load cells were installed in series with each actuator. Additional load cells were attached at the strut of each beam and the jacking point of each post-tensioned rod.

Figure 6: Elevations of the testing apparatus.

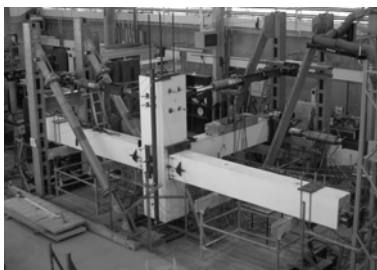
Figure 7: Photograph of the specimen in the testing apparatus.

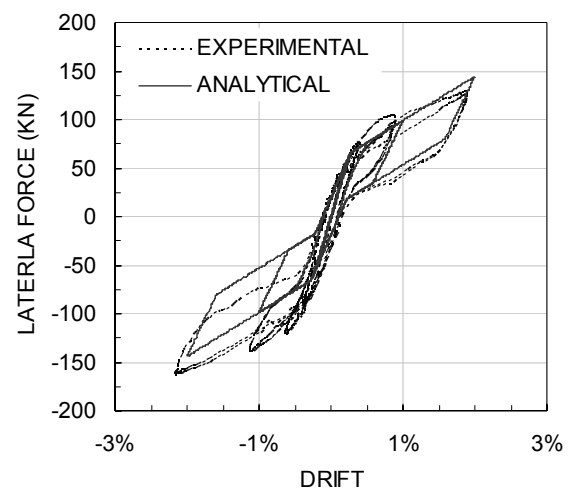
A 3D analytical model of the prototype structure was developed using Ruaumoko3D [16], an inelastic dynamic analysis program. Development of this model was part of a parallel study conducted by the authors; details can be found elsewhere [17]. The hysteresis properties of the joint was calibrated based on uni-directional physical testing of the specimen. Figure 8 gives a comparison between the physical and analytical model up to an interstory drift of 2%.

Figure 8: Experimental-analytical response.

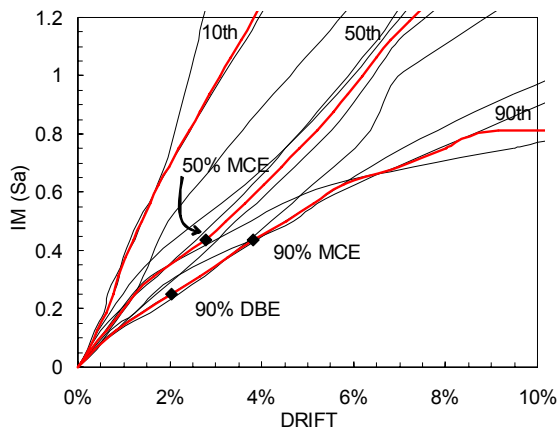
Current seismological studies predict *peak ground acceleration* (PGA) at various return periods. However, it is not correct to simply apply any earthquake record that conforms to this definition, as structural response is dependent on a multitude of factors. Therefore, it is necessary to extract earthquake records from a suite of likely candidates that will result in the most severe structural behaviour. Such a method has been proposed by Dhakal et al. [13] whereby *Incremental Dynamic Analysis* (IDA) [18] is used to probabilistically determine earthquake records representing multiple performance objectives. This method has been adopted herein and is illustrated in Figure 9. Once an IDA has been conducted earthquake records representing different percentile response at a given *intensity measure* (IM) can be extracted. In this study, records were chosen to yield responses that have non-exceedance probabilities of 90% at the DBE, 50% at the MCE, and 90% at the MCE, from a suite of 40 records consisting of medium and near-source ground motions. The selected records are given in Table 1.

Figure 9: Earthquake record selection for the MSPA, using Incremental Dynamic Analysis.

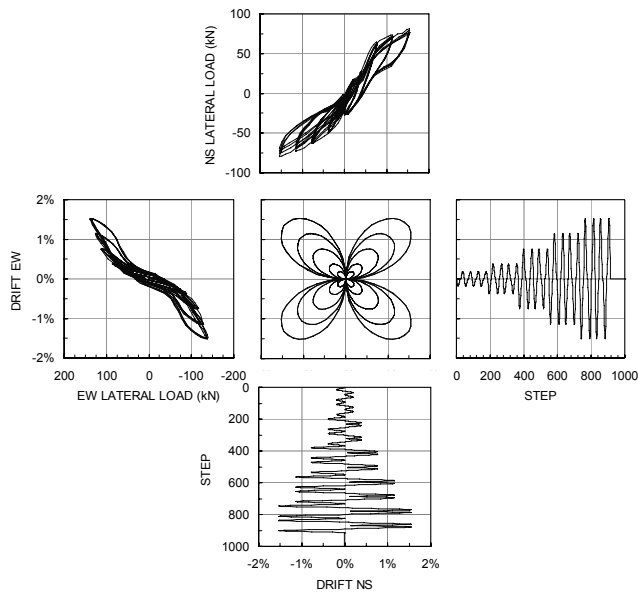
Figure 10 presents results of bi-directional testing to the design level drift of 2%. The results shown are for a bi-directional “clover leaf” test, where total drift is calculated considering both X and Y components. Note that the individual plots are projected to one another, allowing an easy comparison to be made between the NS and EW direction.

Figure 10: Force-displacement response from bi-directional 'clover leaf' test.

As expected, the seismic beam exhibited bi-linear elastic hysteretic behaviour, with some energy dissipation, resulting in a flag-shaped response. Some residual displacement was observed, though this can be partially traced to movement of approximately 2mm in the column base pin, which was repaired for the remaining tests. The unsymmetrical hysteretic response of the gravity beam can be attributed to the inclusion of gravity load, causing an initial positive bending moment at the joint. The gravity beam did not fully re-centre upon removal of the lateral load, resulting in a residual drift of approximately 0.5%. This may be partially attributed to sliding of the base pin.

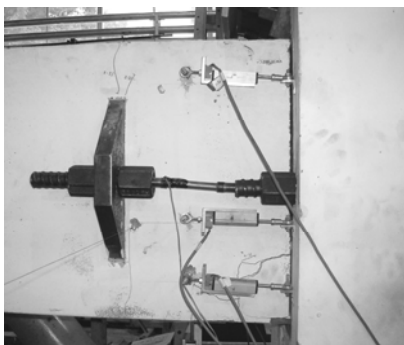
During stressing of the rods, a 1mm crack formed at the bottom edge of each beam, running between the edge of each flange. This crack can be attributed to the vertical component of the diagonal tendons, approximately a 120kN upward force at the joint. This force in effect pulled the beam up the face of the column. The bottom steel flange however, resisted this due to high friction forces, causing tearing just above the angle, as evidenced by this crack.

Opening of the gap was observed at approximately 0.5% drift, at which point the steel dissipaters yielded in tension almost immediately (as evidenced from strain gauges). In the east beam, two hairline cracks formed just before reaching the target drift of 2%, propagating 100mm out from the dissipater anchor plate. The west beam (high-strength concrete) did not suffer additional cracking. Due to the bi-directional rocking, localised crushing was observed behind the top angle of the east beam over a 10mm square area at the top concrete face. At approximately 1% drift, slight buckling of the steel dissipaters occurred as the gap began to close. This was more severe for the gravity beams than the seismic beams, attributed to their longer length. Throughout testing, no damage was observed on the column. A photograph of the east beam after testing is given in Figure 11.

Figure 11: Photograph of the east beam after the bi-directional test to 2% drift.

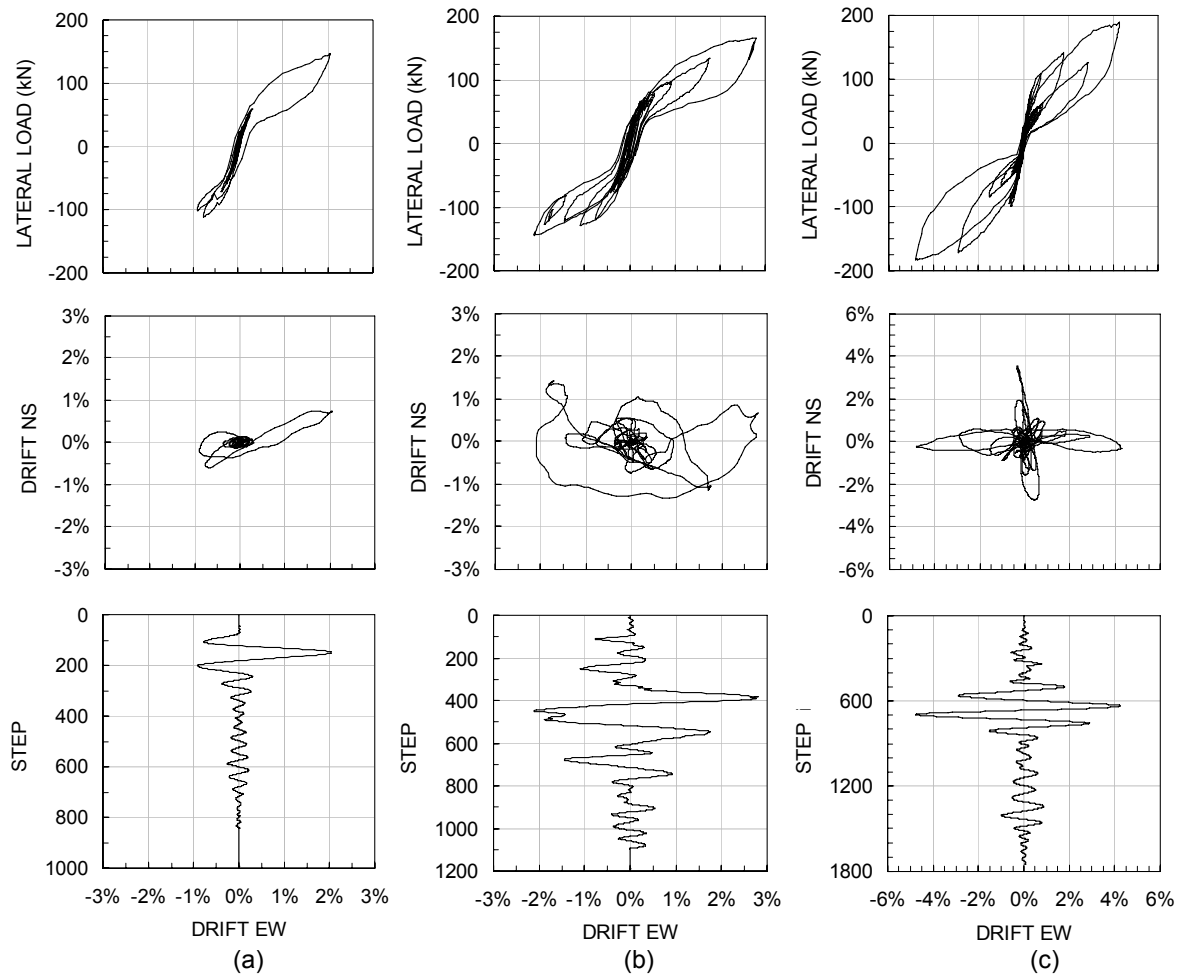
Figure 12 presents results for the seismic beams from the three QED tests. Since the gravity beam had been previously tested as part of a prior study, its response is omitted and can be found elsewhere (Li, 2006). Note that these tests were performed after the initial quasi-static tests (up to 2% drift), and therefore some damage to the specimen had already been observed.

The 90th percentile DBE test consisted of an initial pulse (attributed to the near source record) to the maximum drift of 2.1%. Gap opening and yielding of the energy dissipaters occurred at around the same drift as in previous testing (~0.5%). No new cracks or additional crushing was observed on the seismic beams. A flag shaped hysteresis loop was observed during the initial pulse, however for the remainder of the test response was mostly elastic. Some post-gap opening stiffness degradation was observed, likely due to yielding and buckling of the energy dissipaters. The maximum gap opening, recorded from the potentiometers was approximately 5mm.

The 50th percentile MCE maximum drift was 2.8%, which, like the previous test, occurred in the first major loading cycle. This resulted in considerable yielding of the dissipaters and buckling upon unloading. Consequently, further cycles exhibited a lower capacity, resulting in strength degradation of approximately 20% on the second cycle. A hairline diagonal crack approximately 300mm long was observed on the east and west beam, appearing to be the result of a compression strut. Small (<100mm) hairline cracks formed along the corners of the steel angles of the east beam, but closed after testing. As observed from the strain gauges, the bolt bars reached a maximum of 6000 μ strain ($\epsilon_{yield} \sim 5500$), resulting in slight yielding and an average loss of post-tensioning force of 5%.

The final test, the 90th percentile MCE was the most severe of all tests performed. The maximum drift was 4.7%. Additional crushing was observed along the top and bottom flange of the east beam's steel angle. This crushing was limited to an area of approximately 25mm measured from the flange edge. The bottom flange of the west beam suffered similar crushing, at one end, covering an area of approximately 10mm square. Some spalling was observed over a 25mm area along the angles of both beams. The diagonal cracks formed in the previous test approximately doubled in length and opened to about 1.5mm in the east beam, and 0.5mm in the west beam. At the end of testing, these cracks closed. As seen from the figure, a flag-shaped hysteresis loop was observed, with a maximum residual drift of about 0.1%.

The initial (pre-gap opening) stiffness of the specimen remained virtually unchanged, however. Some minor stiffness and strength degradation was observed in the post-gap opening range. The bolt bars reached a maximum strain of 9000

Figure 12: QED test results for the seismic beams (EW direction) for: (a) the 90% DBE; (b) the 50% MCE; and (c) the 90% MCE.

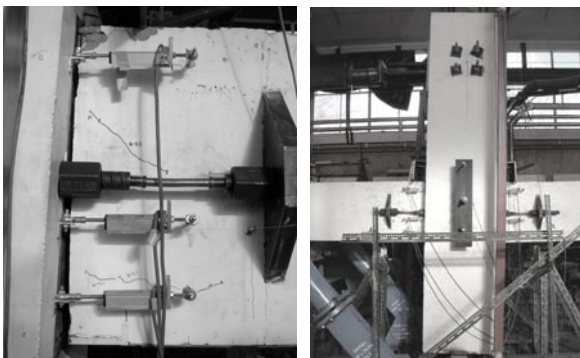
μstrain and maximum force of 360kN, more than the yielding force of the fuse bar. This resulted in a loss of post-tensioning force of approximately 35% and is the major cause of observed strength degradation. Since the yield force of the regular 26.5mm tendon is about 400kN, the bolt bar 'fuse' protected the beam rods from yielding. Two photographs from testing are given in Figure 13.

Figure 13: Photographs of the specimen during the 90th percentile MCE: (left) the west beam joint at 4% drift; and (right) the specimen looking south at the maximum drift of 4.7%.
